Dallas, Oregon Reconnaissance Survey Report

Dallas, Oregon: Reconnaissance Survey Report

Written by: David Pinyerd and Bernadette Niederer
Historic Preservation Northwest
1116 11th Avenue SW
Albany OR 97321
541-791-9199
www.hp-nw.com

Written for: City of Dallas Historic Landmarks Advisory Commission:
Jim Foster
Rich Wolcott
Sue Rohde

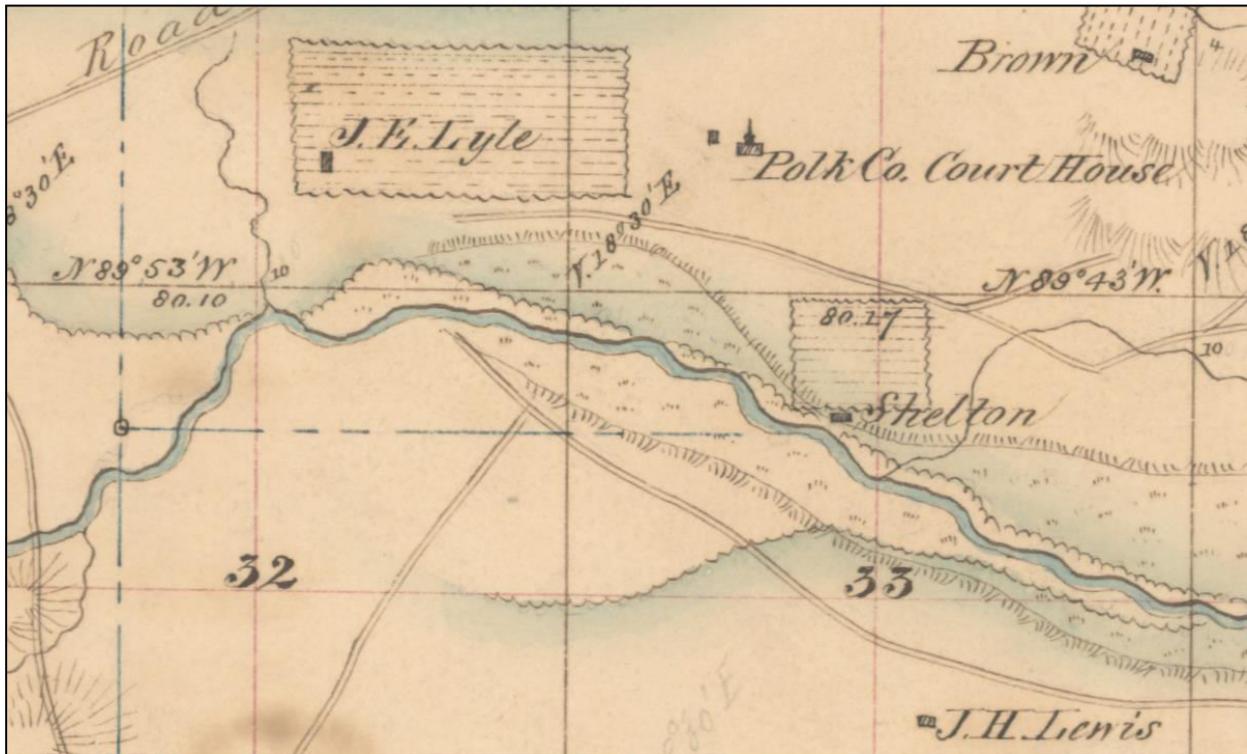
1853 GLO (General Land Office) map of the area that was to become Dallas. The La Creole River runs east-west through the center. The Polk County Courthouse is shown on the north side of the river before its move from Cynthian to the south side of the river in 1856 where it remains today in the center of Dallas.

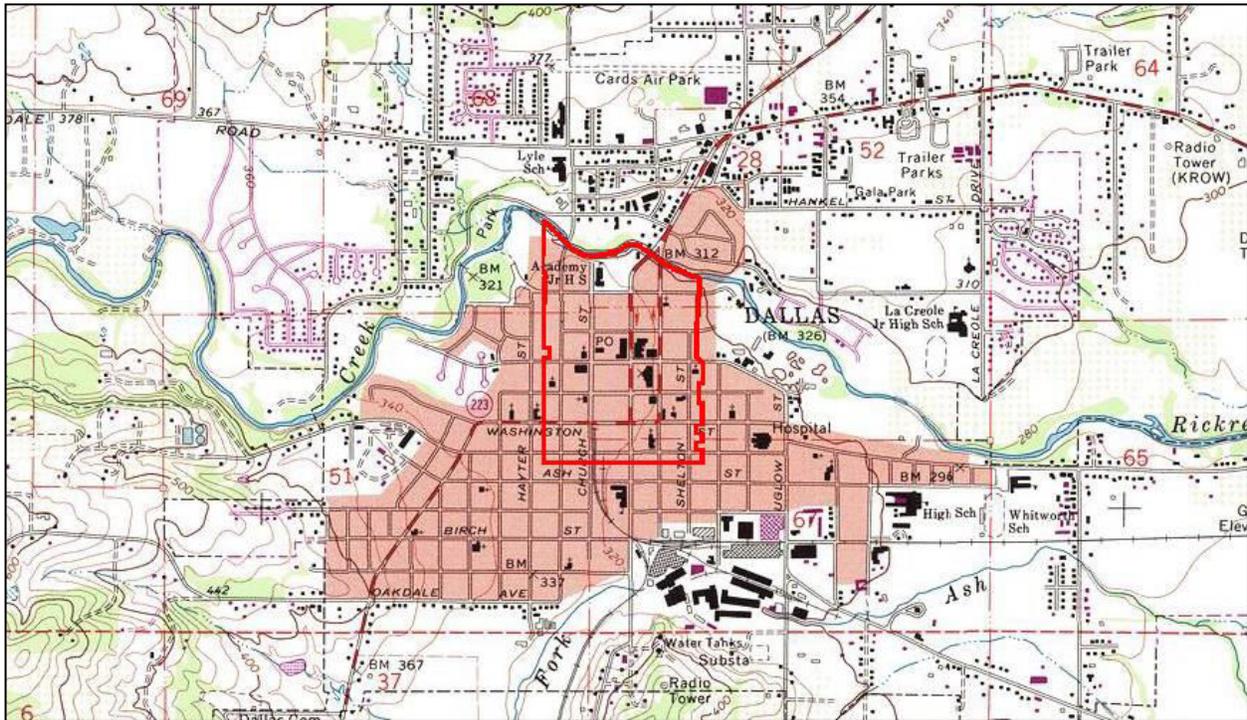
USGS topographic map 7.5 series of Dallas in 1986. The reconnaissance survey area is bounded in red.

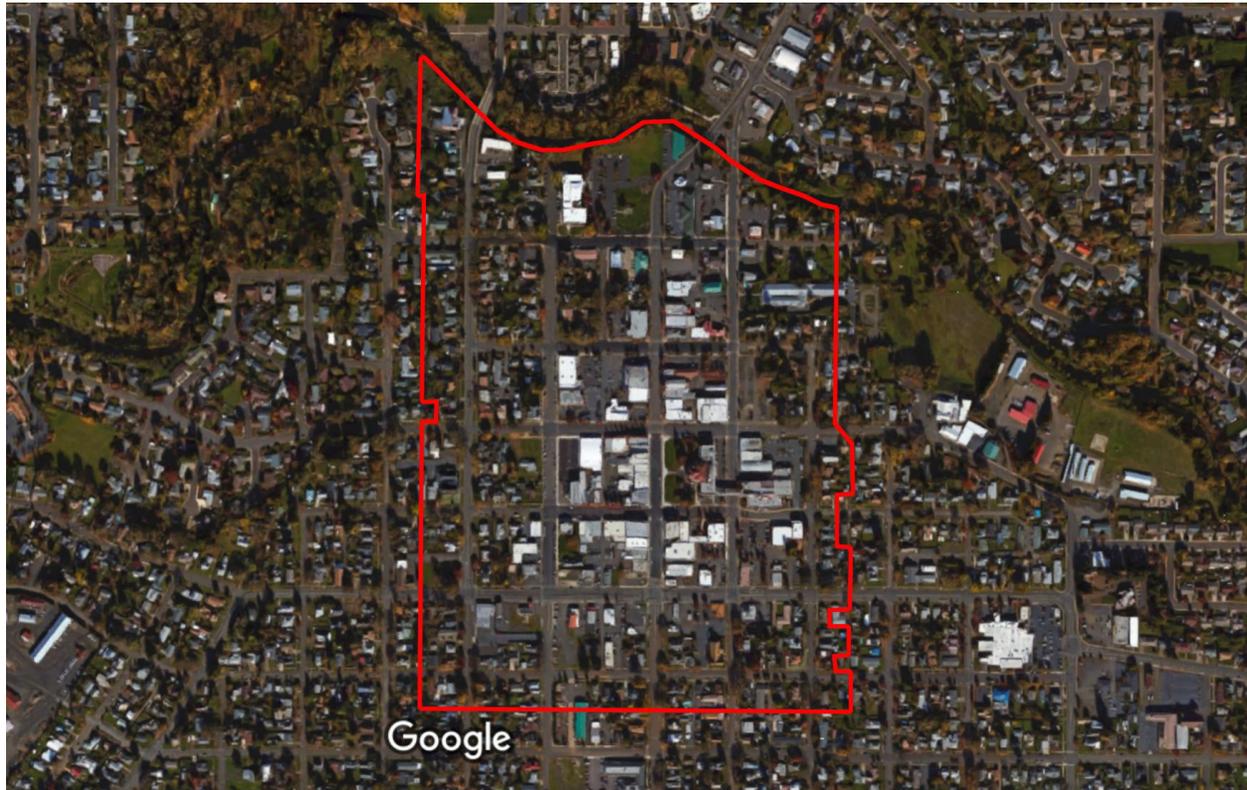
Google aerial from 2020 showing the reconnaissance survey area superimposed over the photo in red.

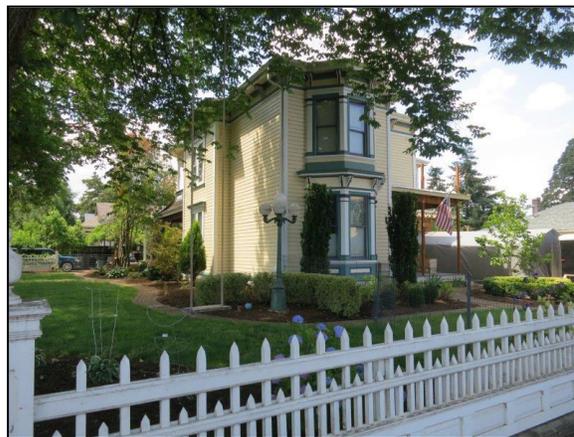
Italianate (1860-1890)

The Italianate style was built in Oregon between around 1860 and 1890. Like Gothic Revival, it is also a style popularized by Downing and Davis meant to romanticize the villas found in Northern Italy. It is characterized by a very low pitch hipped roof, projecting eaves with brackets, tall windows, bay windows, and ornamentation that simulates stone. The house at 591 SW Church Street, built around 1905, is the best example of the style in Dallas.

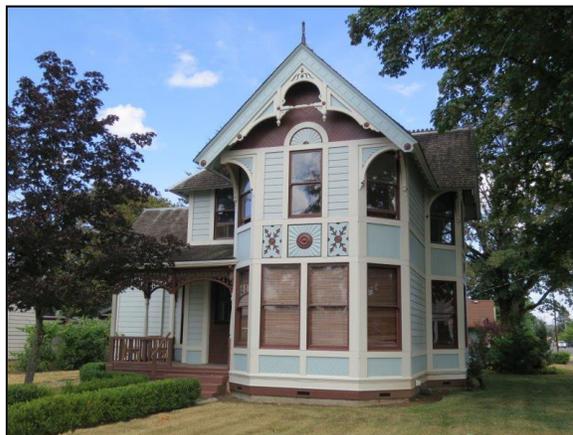
Queen Anne (1880-1905)

The Queen Anne style is characterized by asymmetrical massing, wrap-around porches, and a variety of decorative surfacing materials. Towers are a common feature, as are a variety of window types and turned decorative elements. The style dates back to the 1876 US Centennial Exposition in Philadelphia, where the British sought to re-create the era of Queen Anne in their pavilion buildings. The style was most popular in the Willamette Valley from 1880 to 1900 for wealthier families. The Lovelady House (1887) at 990 SE Shelton Street is an excellent example of a Queen Anne. There were 23 houses flagged as Queen Anne in the survey area, most of which were simpler Queen Anne Cottages.

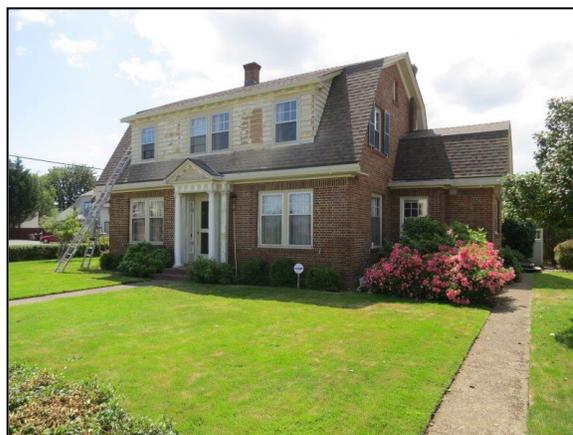
Colonial Revival houses started appearing at the turn of the century in Oregon. The full complement of classical decorative elements was applied to symmetrical forms. An excellent example is the Dutch Colonial Revival substyle at 883 SW Church Street (1932) with its gambrel roof and matching detached garage.

<i>Comments: EC: some window replacement</i>					
883 SW CHURCH St	1.5	ES	1932	Standard Brick	Colonial Revival	Single Dwelling Other Residential Type	7/8/2019

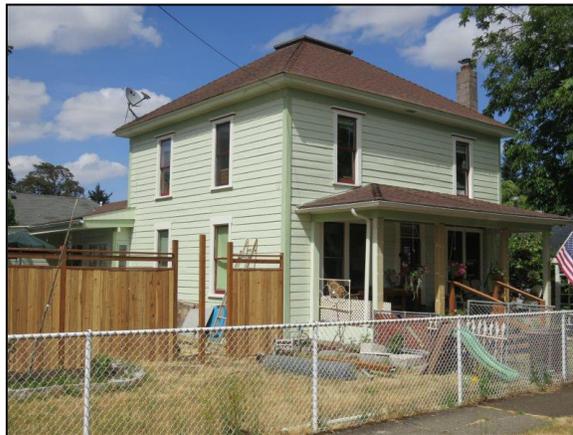
Foursquare (1895-1920)

Less of a style than a form, the foursquare is a hip-roofed, two-story house with a square plan two rooms deep and two rooms wide. Sometimes called a box house or classic box, the foursquare was a common style in Oregon around the turn of the century, from around 1900 until 1915. Foursquares usually have full-width front porches and dormers. Decorative elements are usually confined to the rafter tails and the porch. The only example is at 312 SE Clay Street (c.1900).

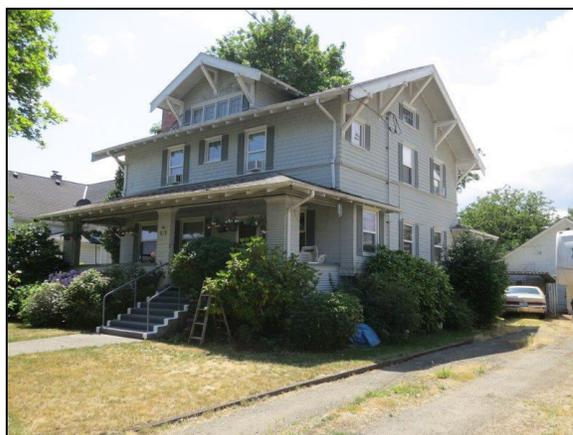
Craftsman (1905-1915)

The Craftsman period was short-lived and ended by 1915 primarily due to high building costs. Rarely is a Craftsman seen in Oregon before 1905. The house at 675 SW Church Street (c.1910) is an excellent example that employs the traits of a Craftsman. There are 29 resources flagged as "Craftsman" in the survey area.

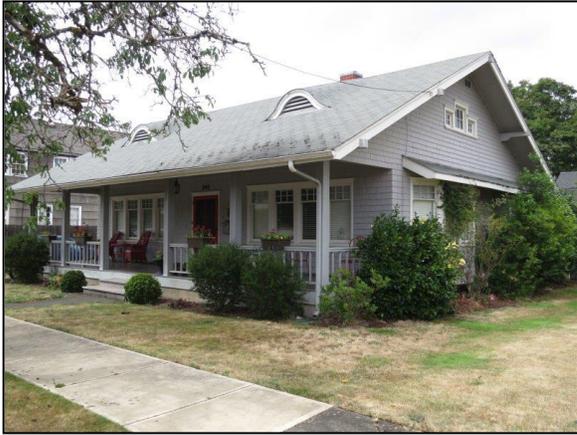
A bungalow is most readily categorized by its size of 1 to 1-1/2 stories. Like the Craftsman, the bungalow is characterized by a low-pitched roof, wide eaves with exposed rafter tails, and brackets. A front porch is critical to the style, as it was to the Queen Anne; however, the bungalow integrates the porch into the building, allowing for a smoother transition from the inside to the outdoors. The porches are wide and are frequently delineated by solid rails with truncated, tapered columns. Also like the Craftsman, bungalows sheath themselves in rustic materials, such as shingles, brick, clinkers, river rock, and stone. A variety of window types are present, often making use of leaded glass treatments. The house at 240 SW Court Street (1912) is an excellent example of a Craftsman bungalow.

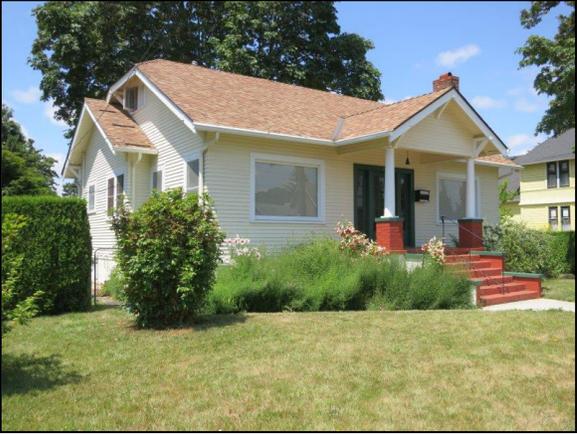
The bungalow evolved somewhat during its popular period of 1910 to 1930. Basically, the style moved from a highly-ornamented, Arts and Crafts-influenced structure to a simpler, more affordable home. This can be seen at the house at 749 SW Levens Street (c.1935). There are 29 resources flagged as “bungalow” in the survey area, most of which are Craftsman Bungalows.

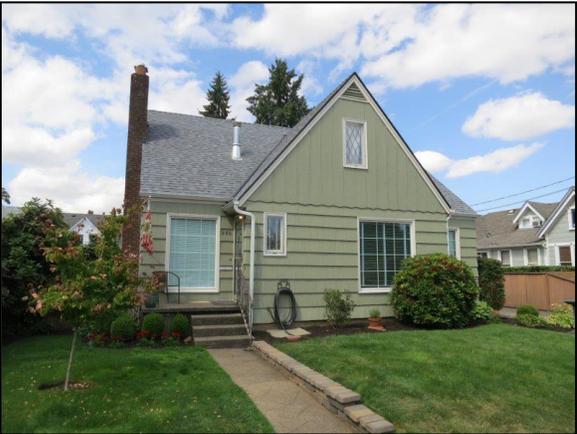
English Cottage (1920-1940)

A subset of the Tudor style is the English Cottage. (There are no examples in the survey area of residential Tudor, only English Cottage.) The English Cottage has all of the elements of the Tudor, but is usually smaller and often has rolled eaves. It will have multiple siding and window types. Often it has a cat slide roof near the entry. Like the Tudor, it has a steeply pitched roof and may even have some half-timbering in the gable. Chimneys are large and prominent. The house at 230 SE Clay Street (c.1940) is a good example.

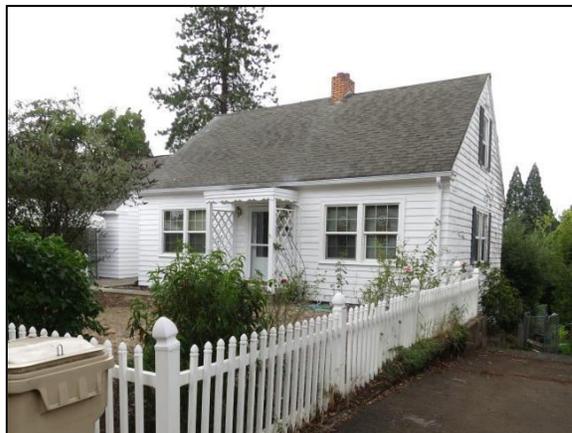
Minimal Traditional (1930-1950)

In response to the Great Depression of the 1930s, houses became less elaborate, but still favored traditional forms and influences. Minimal Traditional houses are simplified, less expensive versions of the eclectic period revival houses of the 1920s. For example, Minimal Traditional houses often feature simplified Colonial detailing and an elaborate exterior wall chimney. The type remained popular in the period immediately following World War II, when resources were still limited and rapid construction was necessary. Buildings are almost always 1-1/2 stories, with medium slope roof pitches and minimal eave overhang. When structures are side-gabled they often feature a smaller front-facing gable. Porches are reduced and often limited to a covering over the front door. A decent example is the house at 254 SE Oak Street (c.1940). There are 15 resources flagged as “Minimal Traditional” in the survey area and all but the one shown are non-contributing due to alterations.

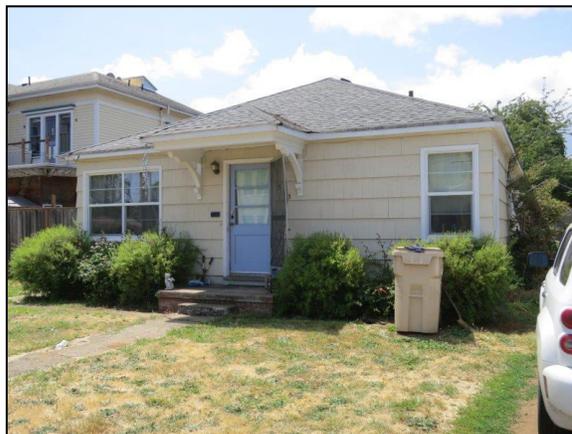
Unlike Minimal Traditional houses which, as the name implies, reference traditional architectural forms, World War II-Era Cottages look forward to a modern age. An increased emphasis on the horizontal plane is reinforced by one-story construction and a newly popular window configuration with panes of glass that are wider than they are tall. A good example can be found at 573 SW Church Street (1938). There are nine resources flagged as “WWII-Era Cottage” in the survey area.

<i>Comments: EC: some window replacement</i>									
573 SW CHURCH St	1	EC	1938	Cedar Shake Shingle	WWII Era Cottage (Type)	Single Dwelling WWII-Era Cottage	7/8/2019

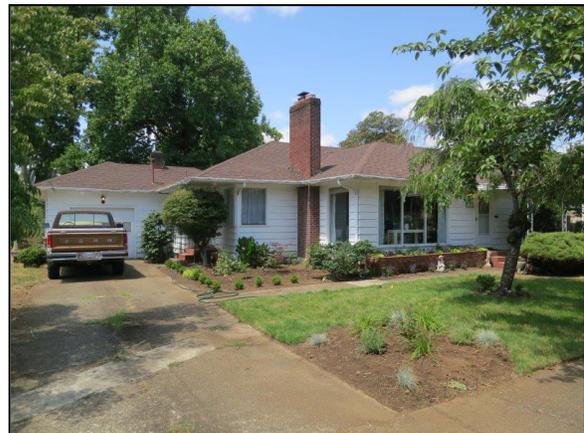
Early Ranch (1945-50)

The Ranch style originated with California architects in the mid-1930s and was the most popular style of architecture from the 1940s through the 1960s. Early Ranches continue the same themes set forth by the Minimal Traditional and WWII-Era Cottage styles. The trend toward increased horizontality continues with one-story buildings and roofs with low-pitches. Multiple siding types begin to appear, particularly novelty drop siding types with added grooves and Roman brick, both of which further emphasize horizontality; however, there are no more than two siding types. Though houses continue to be small, often less than 1000 square feet, they begin to spread across their lots and usually have attached garages. A good example can be found at 627 SW Levens Street (1951).

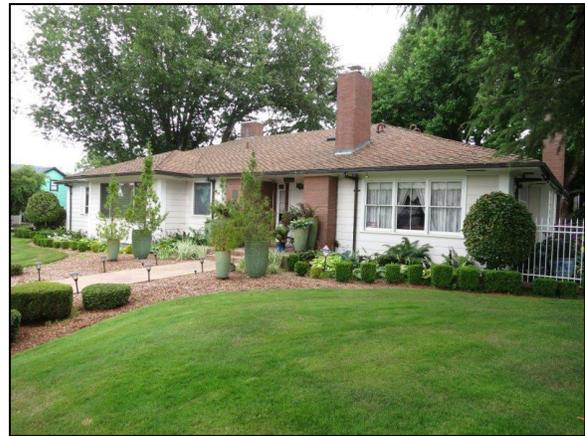
room for two large cars, emphasizing the increased dependence on the automobile and symbolizing urban sprawl in its very form, and are in line with the front of the house. The Ranch style is dominated by asymmetrical, one-story plans with low-pitched roofs and moderate overhangs. Public rooms such as living rooms have large picture windows that are usually fixed, occasionally flanked by narrow sliders. Private rooms tend to have short windows that are set high in the wall, also with sliding sashes. Though wood window sashes still exist, steel and especially aluminum become more prevalent. While Ranches rarely have outright ornament, facades are often decorated with one or more siding types. When the accent cladding is brick, incorporated planters are often present. Some Ranches also have shallow inset porches with iron or wood porch supports, a feature with precedents in the partially enclosed patios and courtyards of the original Spanish Colonial ranches. A superb example can be found at 283 SE Oak Street (1947). There are only nine resources flagged as “Ranch” in the survey area.

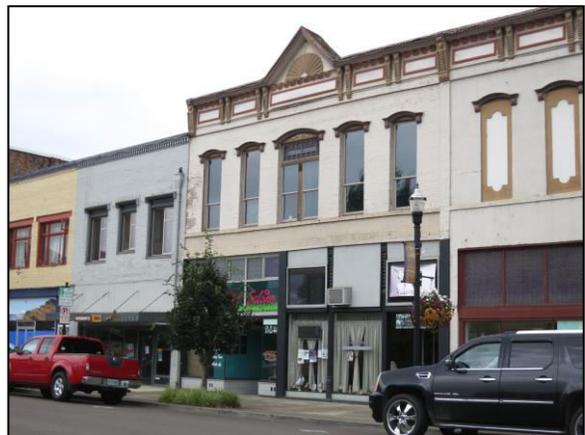
Dallas's historic commercial core, the part that most corresponds to the classic image of "Main Street USA," lies on Main Street between Court and Oak Streets. Like many of its brethren across the nation, Main Street was directly and indirectly shaped by fire. The Sanborn Fire Insurance Map for 1884 shows the west side of Main Street with one- and two-story commercial buildings facing Courthouse Square. A series of fires (1889 and 1896) resulted in a downtown constructed of fire resistant brick. The 1902 issue of the Sanborn Map shows the result of the reconstruction. Tightly spaced commercial buildings with party walls, still one- or two-stories in height, now lined the west side of Main facing a courthouse that replaced an immolated predecessor in 1899-1900.

A typical "Main Street" commercial structure built before 1930 is one- to two- stories in height and has a flat roof. The top of the façade is often ornamented with a cornice, though these were often removed in later years due to maintenance and safety concerns. The primary cladding is brick, sometimes covered with stucco. The ground floors are defined by storefronts with large glazed openings. Second story windows are primarily double-hung. The buildings from the 1890s may show Italianate influences with arched second story windows, such as the Brown Building (1889) at 861-865 Main Street. Slightly later buildings show the influence of the Chicago style with its wider, three-part window openings, as well as the neoclassical influence of the Beaux-Arts, as seen in the IOOF Lodge (c.1900) at 837 Main Street.

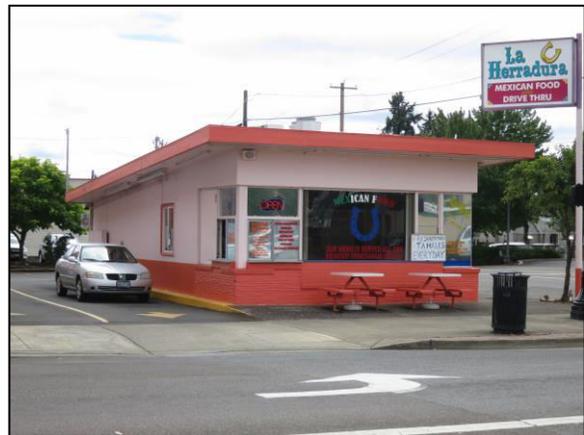
The conversion to car culture was essentially complete by the end of World War II. Later commercial structures no longer needed to be in a downtown cluster in order to provide easy access for customers. What they needed instead was parking and an eye-catching gimmick to entice passing motorists. Today's La Herradura (c.1950) at 994 Main Street, ticks all the boxes: corner location outside the downtown core, drive-up, parking, and a large lighted sign.

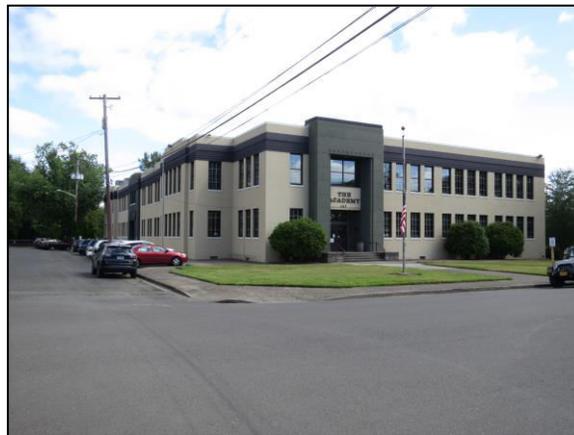
Education

There was only one educational building in the survey area but it was an important one, the former La Creole Academy at 182 SW Academy Street. The original goal of the town of Dallas on the south side of the La Creole River was to finance an academy by selling lots – property sales is what successfully funded the school. The original school on the site was demolished in 1924, and then the current façade built in 1939. As with schools, it continued to expand with a large remodel in the 1990s and its name was simplified to The Academy and is now the Dallas Community Resource Center. Concrete bleachers still remain in the southeast corner from the former baseball field.

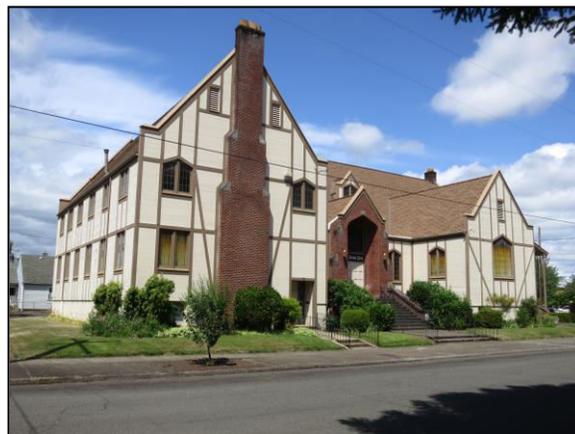
There are numerous religious buildings within the survey area. There are four buildings flagged as “church-related” and most of them are imposing structures. Three of them are already listed on the local register and all are from the early 1900s. The First Christian Church (c.1915) at 1079 SE Jefferson Street is the only building in the survey area that could be classified as Tudor Revival with its half-timbering, and is one of those listed on the local register.

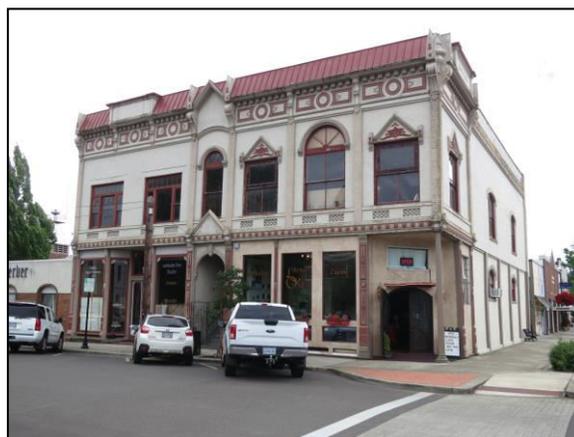
The oldest social hall that remains is the former Odd Fellows Hall (1890) at 904 Main Street. It has the most ornate façade in Dallas and has a high level of integrity. Its form is typical of such establishments in the late 19th- and early 20th centuries with fraternal spaces on the upper floor and commercial spaces at ground level.

The other two social halls are the current Odd Fellows Hall (c.1900) at 837 Main Street and the Masonic Lodge (c.1910) next door at 827 Main Street. Both are arranged in the same format with commercial at the street level and meeting spaces upstairs; however, the Masons meet on the third floor, the only three-story building in town.

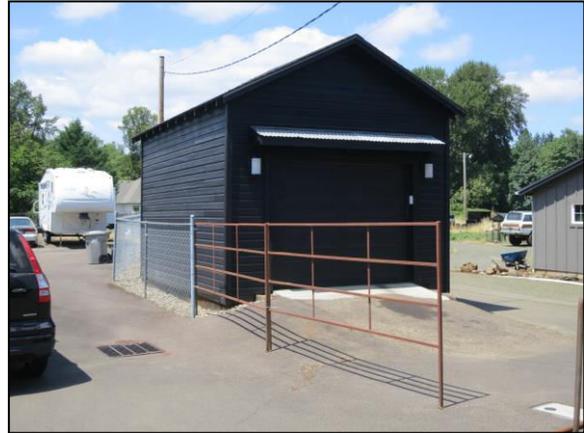
Manufacturing

The manufacturing theme is represented by only one of the inventoried properties in the survey area: the Dallas Tannery. It was such an important historic resource that it was listed on the National Register in 1980. Unfortunately, the tannery was torn down in 2014. One building remains, the former scale house. A shed-portion of the tannery was incorporated into a new residence but the portion is unrecognizable today as part of the tannery operation.

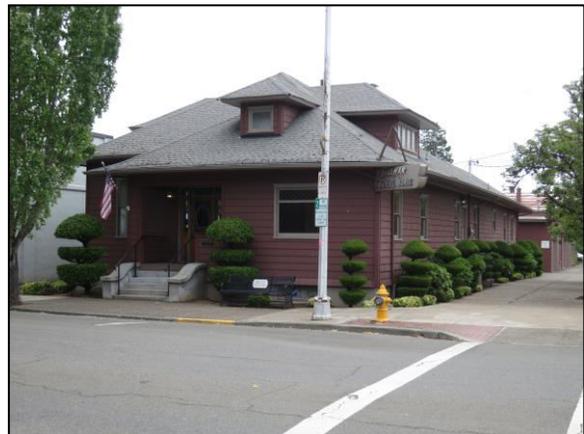
Funerary

The Bollman Funeral Home at 694 Main Street retains a great deal of its integrity. It was a purpose-built funeral home in 1890 and remodeled into a bungalow in 1910. To the east of the building at 158 SE Oak Street are shop buildings formerly associated with the funeral home. The Bollmans bought the existing funeral home from the Chapmans in 1934, and the Bollmans still operate it today.

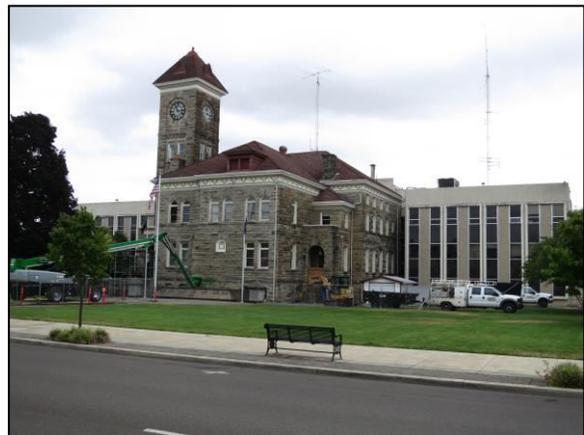
There are five resources that fall into the government theme within the survey area: the city hall, the county courthouse, the current library, the Carnegie library, and the former post office. The new fire station and post office were too new to survey. The Polk County Courthouse (1899-1900) is already on the local register. The City Hall and Carnegie Library should both be considered for the local register.
