Dallas, Oregon Reconnaissance Survey Report

Dallas, Oregon: Reconnaissance Survey Report

Historic Preservation Northwest (HPNW) was hired by the City of Dallas to perform a historic resources reconnaissance-level survey (RLS) of the City's historic downtown core. The reconnaissance survey of the downtown core provided an inventory of the resources built in a survey area pre-defined by the City.

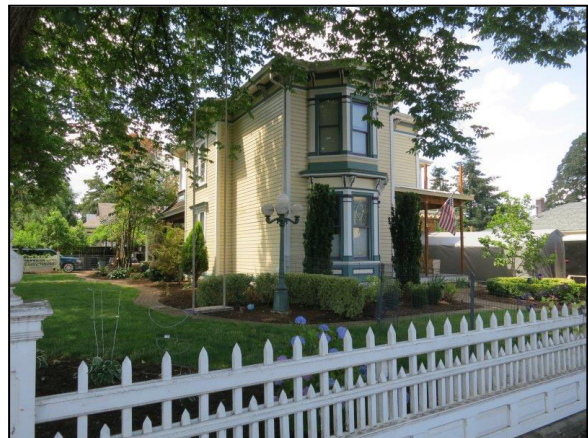
The Italianate style was built in Oregon between around 1860 and 1890. Like Gothic Revival, it is also a style popularized by Downing and Davis meant to romanticize the villas found in Northern Italy. It is characterized by a very low pitch hipped roof, projecting eaves with brackets, tall windows, bay windows, and ornamentation that simulates stone. The house at 591 SW Church Street, built around 1905, is the best example of the style in Dallas.

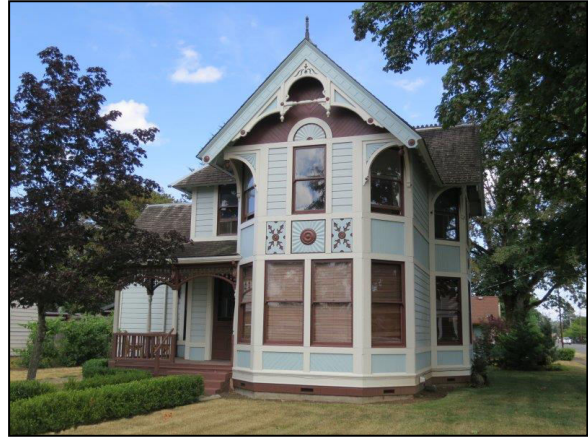
The Queen Anne style is characterized by asymmetrical massing, wrap-around porches, and a variety of decorative surfacing materials. Towers are a common feature, as are a variety of window types and turned decorative elements. The style dates back to the 1876 US Centennial Exposition in Philadelphia, where the British sought to re-create the era of Queen Anne in their pavilion buildings. The style was most popular in the Willamette Valley from 1880 to 1900 for wealthier families. The Lovelady House (1887) at 990 SE Shelton Street is an excellent example of a Queen Anne. There were 23 houses flagged as Queen Anne in the survey area, most of which were simpler Queen Anne Cottages.

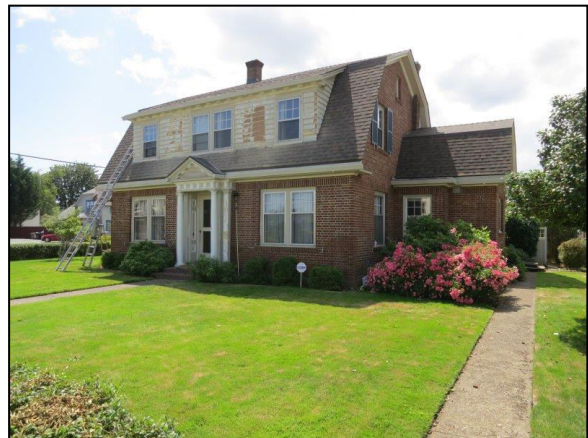
Colonial Revival houses started appearing at the turn of the century in Oregon. The full complement of classical decorative elements was applied to symmetrical forms. An excellent example is the Dutch Colonial Revival substyle at 883 SW Church Street (1932) with its gambrel roof and matching detached garage.

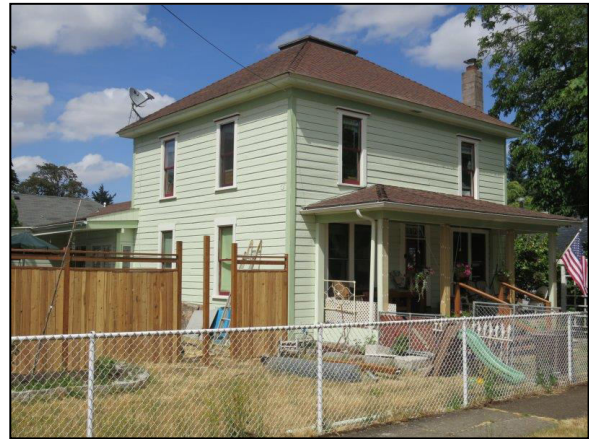
Less of a style than a form, the foursquare is a hip-roofed, two-story house with a square plan two rooms deep and two rooms wide. Sometimes called a box house or classic box, the foursquare was a common style in Oregon around the turn of the century, from around 1900 until 1915. Foursquares usually have full-width front porches and dormers. Decorative elements are usually confined to the rafter tails and the porch. The only example is at 312 SE Clay Street (c.1900).

<i>Comments: EC: one window replacement, early additions</i>						
312 SE CLAY St	2	EC	c.1900	Horizontal Board	Foursquare (Type)	Single Dwelling Foursquare (Box)	7/8/2019

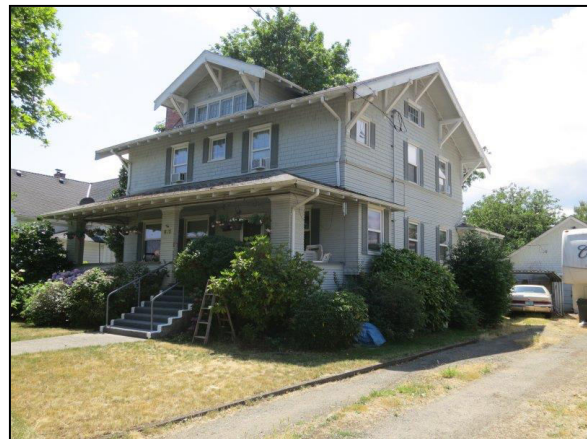
The Craftsman period was short-lived and ended by 1915 primarily due to high building costs. Rarely is a Craftsman seen in Oregon before 1905. The house at 675 SW Church Street (c.1910) is an excellent example that employs the traits of a Craftsman. There are 29 resources flagged as "Craftsman" in the survey area.

<i>Comments: NC: window replacement, siding replacement</i>						
675 SW CHURCH St	2.5	EC	c.1910	Horizontal Board Shingle	Craftsman	Single Dwelling Bungalow	7/8/2019

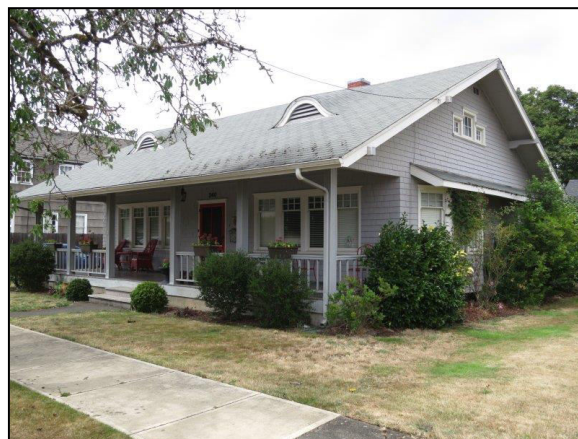
A bungalow is most readily categorized by its size of 1 to 1-1/2 stories. Like the Craftsman, the bungalow is characterized by a low-pitched roof, wide eaves with exposed rafter tails, and brackets. A front porch is critical to the style, as it was to the Queen Anne; however, the bungalow integrates the porch into the building, allowing for a smoother transition from the inside to the outdoors. The porches are wide and are frequently delineated by solid rails with truncated, tapered columns. Also like the Craftsman, bungalows sheath themselves in rustic materials, such as shingles, brick, clinkers, river rock, and stone. A variety of window types are present, often making use of leaded glass treatments. The house at 240 SW Court Street (1912) is an excellent example of a Craftsman bungalow.

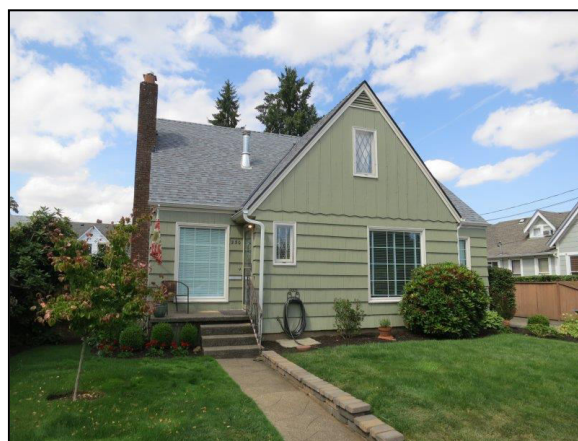
A subset of the Tudor style is the English Cottage. (There are no examples in the survey area of residential Tudor, only English Cottage.) The English Cottage has all of the elements of the Tudor, but is usually smaller and often has rolled eaves. It will have multiple siding and window types. Often it has a cat slide roof near the entry. Like the Tudor, it has a steeply pitched roof and may even have some half-timbering in the gable. Chimneys are large and prominent. The house at 230 SE Clay Street (c.1940) is a good example.

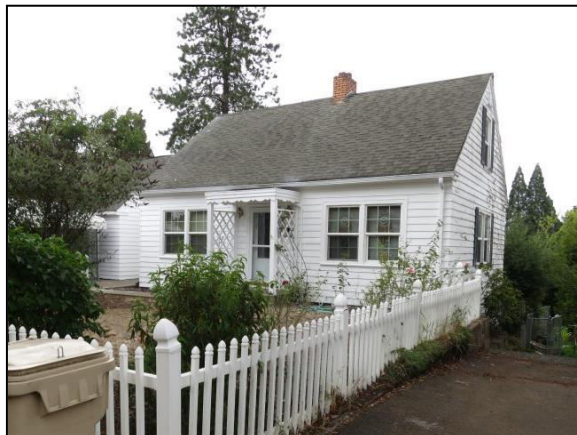
In response to the Great Depression of the 1930s, houses became less elaborate, but still favored traditional forms and influences. Minimal Traditional houses are simplified, less expensive versions of the eclectic period revival houses of the 1920s. For example, Minimal Traditional houses often feature simplified Colonial detailing and an elaborate exterior wall chimney. The type remained popular in the period immediately following World War II, when resources were still limited and rapid construction was necessary. Buildings are almost always 1-1/2 stories, with medium slope roof pitches and minimal eave overhang. When structures are side-gabled they often feature a smaller front-facing gable. Porches are reduced and often limited to a covering over the front door. A decent example is the house at 254 SE Oak Street (c.1940). There are 15 resources flagged as “Minimal Traditional” in the survey area and all but the one shown are non-contributing due to alterations.

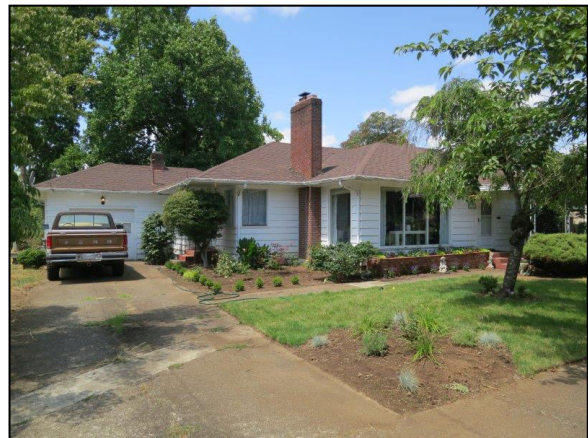
The Ranch style originated with California architects in the mid-1930s and was the most popular style of architecture from the 1940s through the 1960s. Early Ranches continue the same themes set forth by the Minimal Traditional and WWII-Era Cottage styles. The trend toward increased horizontality continues with one-story buildings and roofs with low-pitches. Multiple siding types begin to appear, particularly novelty drop siding types with added grooves and Roman brick, both of which further emphasize horizontality; however, there are no more than two siding types. Though houses continue to be small, often less than 1000 square feet, they begin to spread across their lots and usually have attached garages. A good example can be found at 627 SW Levens Street (1951).

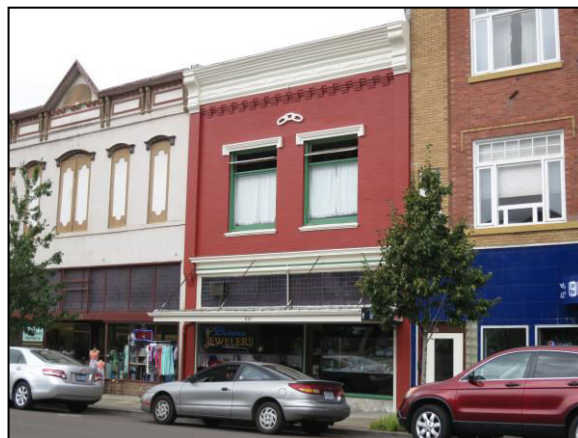
A typical "Main Street" commercial structure built before 1930 is one- to two- stories in height and has a flat roof. The top of the façade is often ornamented with a cornice, though these were often removed in later years due to maintenance and safety concerns. The primary cladding is brick, sometimes covered with stucco. The ground floors are defined by storefronts with large glazed openings. Second story windows are primarily double-hung. The buildings from the 1890s may show Italianate influences with arched second story windows, such as the Brown Building (1889) at 861-865 Main Street. Slightly later buildings show the influence of the Chicago style with its wider, three-part window openings, as well as the neoclassical influence of the Beaux-Arts, as seen in the IOOF Lodge (c.1900) at 837 Main Street.

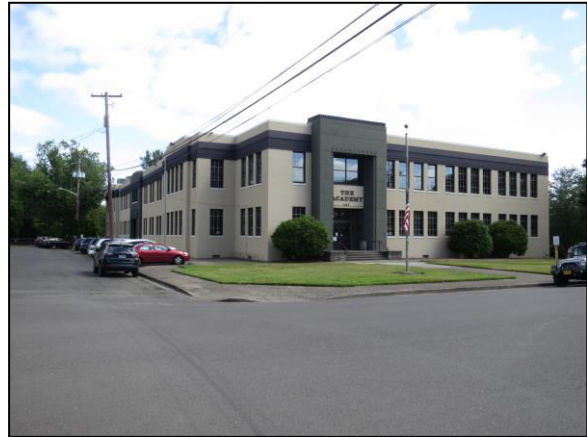
There was only one educational building in the survey area but it was an important one, the former La Creole Academy at 182 SW Academy Street. The original goal of the town of Dallas on the south side of the La Creole River was to finance an academy by selling lots – property sales is what successfully funded the school. The original school on the site was demolished in 1924, and then the current façade built in 1939. As with schools, it continued to expand with a large remodel in the 1990s and its name was simplified to The Academy and is now the Dallas Community Resource Center. Concrete bleachers still remain in the southeast corner from the former baseball field.

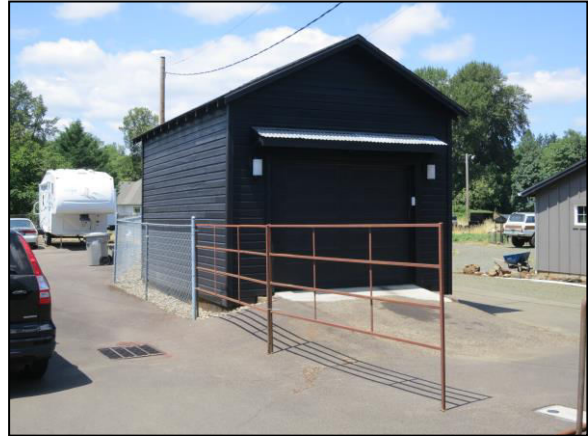
The manufacturing theme is represented by only one of the inventoried properties in the survey area: the Dallas Tannery. It was such an important historic resource that it was listed on the National Register in 1980. Unfortunately, the tannery was torn down in 2014. One building remains, the former scale house. A shed-portion of the tannery was incorporated into a new residence but the portion is unrecognizable today as part of the tannery operation.

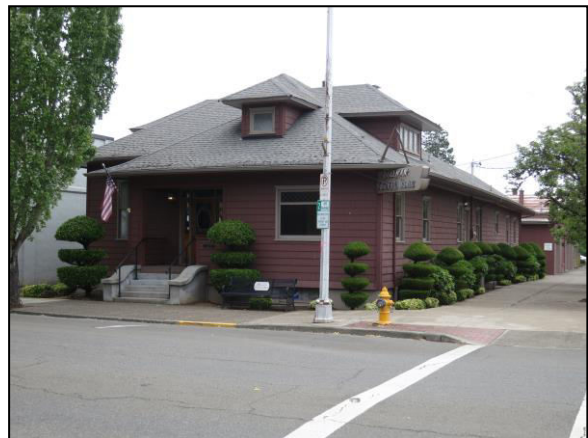
The Bollman Funeral Home at 694 Main Street retains a great deal of its integrity. It was a purpose-built funeral home in 1890 and remodeled into a bungalow in 1910. To the east of the building at 158 SE Oak Street are shop buildings formerly associated with the funeral home. The Bollmans bought the existing funeral home from the Chapmans in 1934, and the Bollmans still operate it today.
